## Sulfate attack of Algerian cement-based material with crushed limestone filler cured at different temperatures

### Abstract

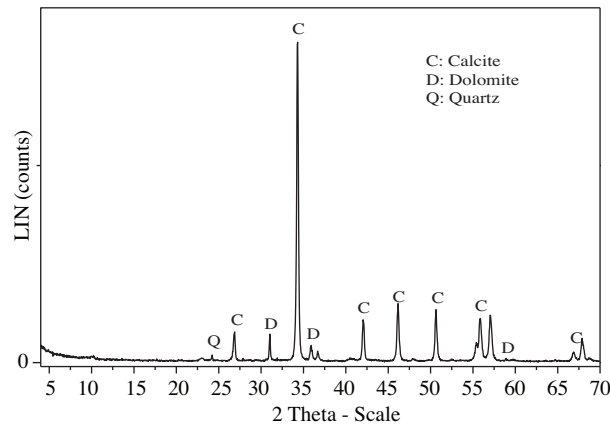
**Figure 1.** X-ray diffractogram of crushed limestone.

*Limestone* The limestone was obtained from limestone quarries in the city of Oran. It was ground to a specific surface area of 3200 cm<sup>2</sup>/g, with a maximum nominal size of 0.080 mm. Its content of CaCO<sub>3</sub> was about 86.98%. The X-ray diffractogram of limestone is shown in Figure 1. Its chemical composition is given in Table 1. The chemical composition of the materials was determined by X-ray fluorescence (XRF).

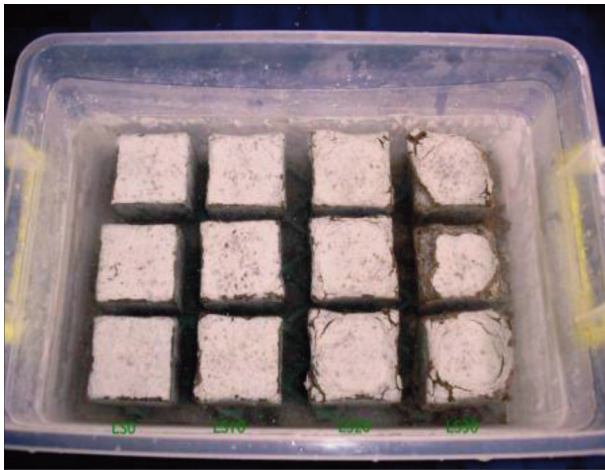
**Figure 2.** Mortar cubes (50 mL) exposed to 5% magnesium sulfate solution for 360 days at 5 °C.

The specimens were visually examined on a regular basis. Photos of specimens stored in the magnesium sulfate solution for 360 days are presented in Figures 2 and 3. The samples stored at 5 °C showed the first signs of deterioration after 5 months of exposure, while the specimens stored at 23 °C did not show any clear evidence of sulfate attack for up to 9 months. The discussion below concerns the samples stored at 5 °C. In all cases, the first sign of attack was the deterioration of the corners, followed by cracking along the edges. Progressively, expansion and spalling took place on the surface of the specimens.

After 5 months of immersion in a solution of 5%  $\text{MgSO}_4$  at 5 °C, all 4 surfaces of the specimens developed a white cover that was friable and started to peel off, leaving the aggregates uncovered and reducing the connectivity of the paste. As can be seen from Figure 2, it was clearly observed that the degree of surface deterioration was different with the replacement levels of limestone filler. The extent of surface deterioration after 360 days of exposure had a tendency to increase with the increased replacement level of the limestone filler. The LS30 mortar sample displayed many wide cracks, spalling, and substantial material loss at the faces as well as at the corners and edges, while the LS0 mortar sample only exhibited cracks around the corners and edges.

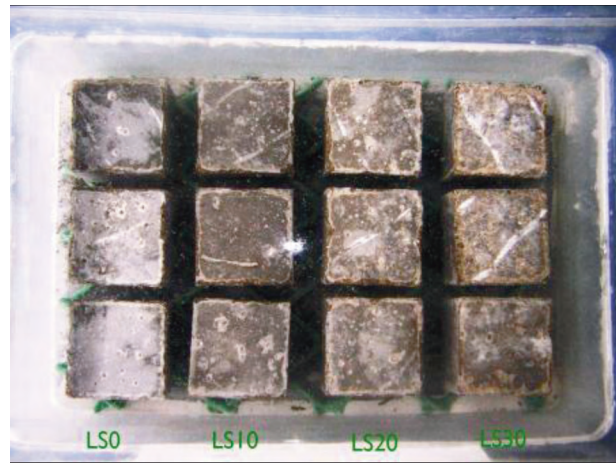
**Figure 3.** Mortar cubes (50 mL) exposed to 5% magnesium sulfate solution for 360 days at 23 °C.

The specimens preserved in a solution of 5%  $\text{MgSO}_4$  at 23 °C for a year did not present any surface damage, except for some deterioration at corners (Figure 3). Both mortars, with and without limestone addition, had the same behavior under the same preservation conditions, and it seems that the damage proceeded independently of limestone addition. Consequently, the specimens' surface damage appears to have been inversely related to the temperature of conservation. It is noteworthy that the specimens that were preserved at 23 °C had approximately the same damage that specimens preserved in a solution of 5%  $\text{MgSO}_4$  at 5 °C had at the age of 3 months, which was also limited only to one surface of the mortars.

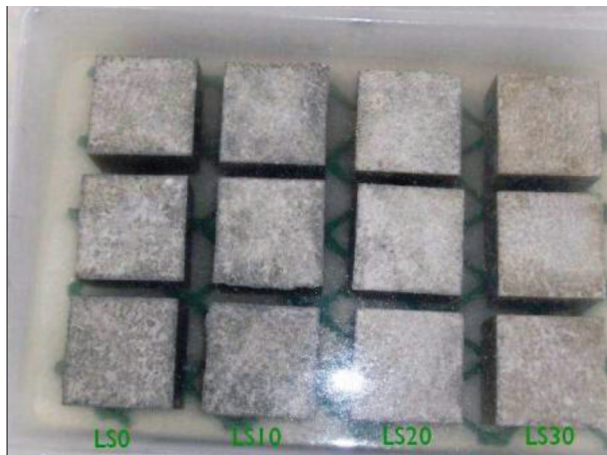
**Figure 4.** Mortar cubes (50 mL) cured in tap water for 360 days at 5 °C.

Photos of specimens stored in tap water for 12 months at 5 °C and 23 °C are presented respectively in

Figures 4 and 5. After the initial 30-day curing under water, a little white precipitate was present in the sample containers, particularly on the top surface of the specimens. This material is attributed to the portlandite ( $\text{Ca}(\text{OH})_2$ ) leaching out from the mortar and a little carbonate in the water. With the increasing curing under water, the precipitate accumulated continuously, and a white powdery coating formed on the whole top surface and partial side surface of the control specimens when immersed for 1 year. However, storage in water appeared to be benign; no evidence of cracking or spalling was detected on the control samples during the whole experiment.

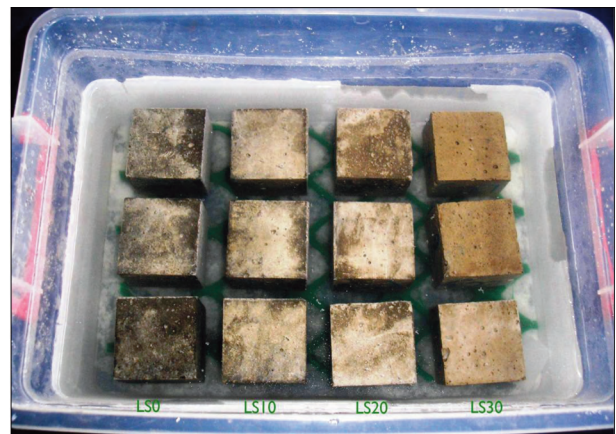
**Figure 5.** Mortar cubes (50 mL) cured in tap water for 360 days at 23 °C.

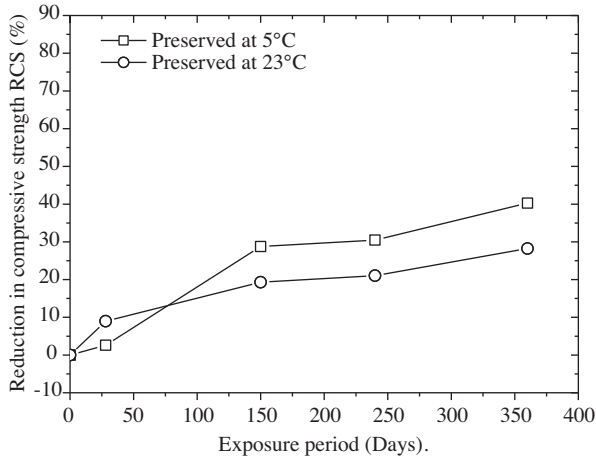
**Figure 6.** Reduction in the compressive strength of LS0 mortar specimens exposed to 5% magnesium sulfate solution at 5 °C and 23 °C.

The compressive strength decreased with the period of exposure. Figure 6 shows the RCS of mortar specimens LS0 immersed in a magnesium sulfate solution and stored at 5 °C and 23 °C. For the LS0 mortar specimens, the RCS was almost linear after 28 days of exposure. This shows that the compressive strength of the LS0 cement mortar specimens decreased from 1% to 22% and from 4% to 15% within 12 months of exposure to the sulfate solution cured at 5 °C and 23 °C, respectively. The strength reduction in LS10, the cement mortar specimens with 10% limestone, was almost similar and did not vary much, with the RCS of LS10 being in the range of 3%-24% for specimens stored at 5 °C and in the range of 2%-17% for the mortars preserved at 23 °C (Figure 7).

As can be seen from Figures 6-10, a decrease of storage temperature indicated a more pronounced deterioration of all mortar specimens with or without limestone compared to the mortar specimens immersed in magnesium sulfate solution at 23 °C.

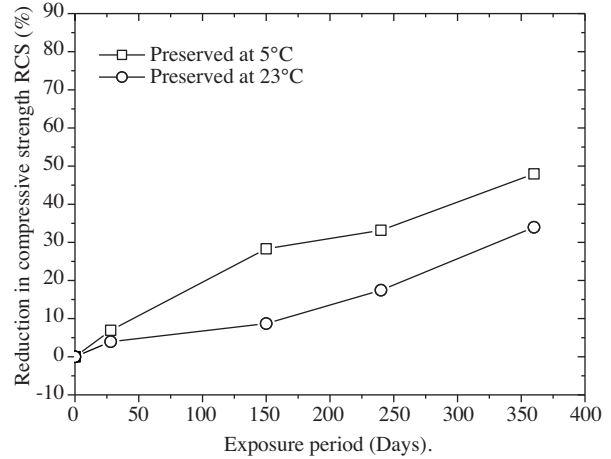
**Figure 7.** Reduction in the compressive strength of LS10 mortar specimens exposed to 5% magnesium sulfate solution at 5 °C and 23 °C.

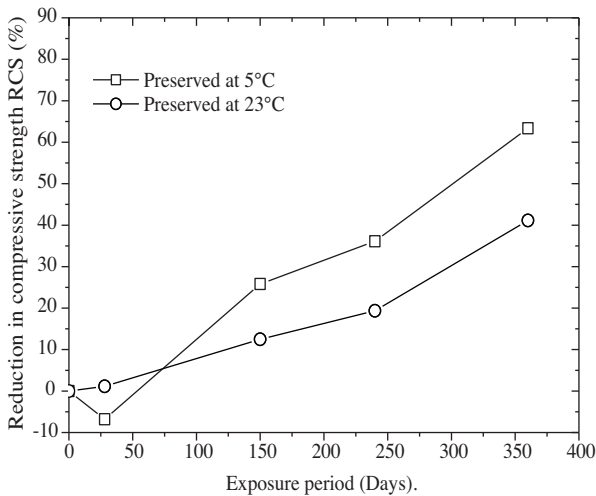
**Figure 8.** Reduction in the compressive strength of LS20 mortar specimens exposed to 5% magnesium sulfate solution at 5 °C and 23 °C.

Figures 8 and 9 show the compressive strength in blended cement mortar specimens LS20 and LS30. The results exhibited an initially marginally negative compressive strength loss/gain, which was more pronounced for the LS20 and LS30 mortar mixtures conserved at 5 °C after 28 days. This phenomenon is attributable to

the filling up of pores by the expansive reaction products, thereby densifying the hardened mortar mix and increasing the weight and strength (Montemor et al., 2000).

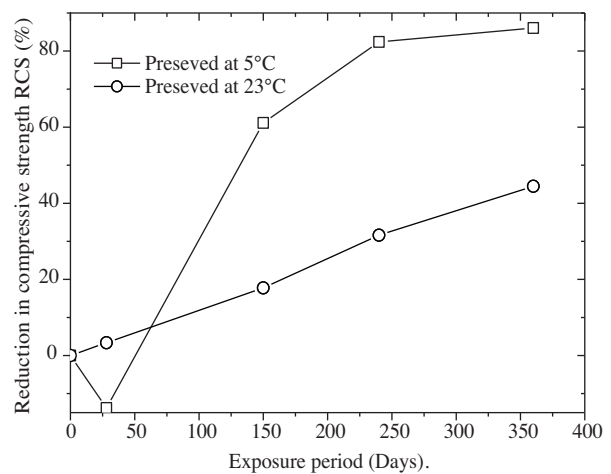
**Figure 9.** Reduction in the compressive strength of LS30 mortar specimens exposed to 5% magnesium sulfate solution at 5 °C and 23 °C.

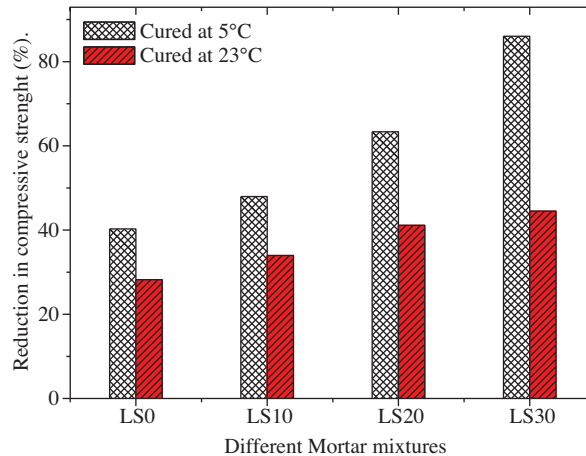
**Figure 10.** Reduction in the compressive strength of LS0, LS10, LS20, and LS30 mortar specimens exposed to 5% magnesium sulfate solution at 5 °C and 23 °C after 360 days.

These results also emphasize that the incorporation of 20% and 30% limestone filler leads to an increased strength loss compared to that of the LS0 mortar specimens, regardless of the conservation temperature. The negative effect of the higher replacement level of limestone filler was observed more remarkably. With respect to the strength loss of mortar specimens after an exposure of 360 days (Figure 10), the worst performance was observed in all mortar specimens exposed to the magnesium sulfate solution at 5 °C, compared to the same mortar specimens exposed to the magnesium sulfate solution preserved at 23 °C.

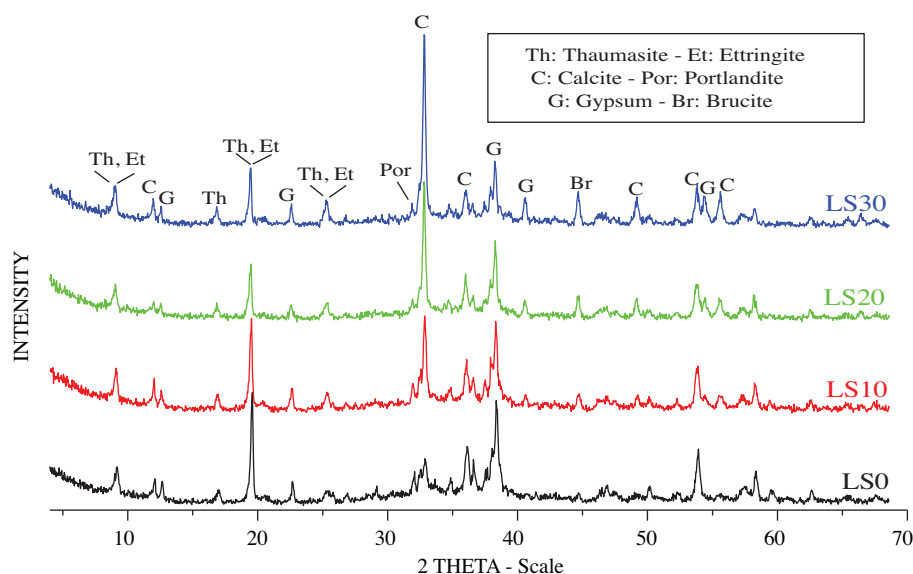
**Figure 11.** XRD patterns of the damaged surface of the mortars with 0%, 10%, 20%, and 30% limestone preserved at 5 °C for 12 months.

*X-ray diffraction* Measurements were carried out on samples from the deteriorated parts of the specimens. Figure 11 shows the XRD patterns for the powdered samples from the paste specimens exposed to magnesium sulfate solution at 5 °C. These patterns indicated the presence of ettringite (Et), thaumasite (Th), gypsum (G), portlandite (Por), calcite (C), and brucite (Br), which are the expected products formed by cement hydration and magnesium sulfate attack. The relatively strong calcite peaks detected in the LS10, LS20, and LS30 paste samples were due to the replacement of cement by limestone filler. The gypsum peaks were very strong, especially in the LS30 paste sample, compared to the peaks of other products formed.

There were very weak peaks for portlandite ( $\text{Ca}(\text{OH})_2$ ) in the XRD patterns of the LS20 and LS30 paste samples. Portlandite most probably had reacted with magnesium sulfate to form gypsum and brucite, both present in the degradation products.

Furthermore, for the LS20 and LS30 paste samples, the ettringite and/or thaumasite peaks were very intense compared to those in the LS0 paste sample. Ettringite and thaumasite have similar crystal structures, and their XRD patterns show similarities at the 2 major peaks around  $9.1^\circ$  and  $16.0^\circ$   $2\theta$  (Soroka and Stern, 1976; Hartshorn et al., 1999). This suggests that, in the case of cement systems incorporating high levels of limestone filler under a magnesium sulfate environment, one of the primary causes for sulfate damage may be thaumasite formation, but not gypsum formation. Although thaumasite formation is frequently regarded as a low-temperature phenomenon, it can also be detected in paste specimens exposed at ambient conditions (Brown et al., 2002; Hartshorn et al., 2002). The coexistence of gypsum and brucite ( $\text{Mg}(\text{OH})_2$ ), in combination with the absence of portlandite, leads to the conclusion that portlandite, most probably, had reacted with magnesium sulfate to form gypsum and brucite, according to Eq. (2):

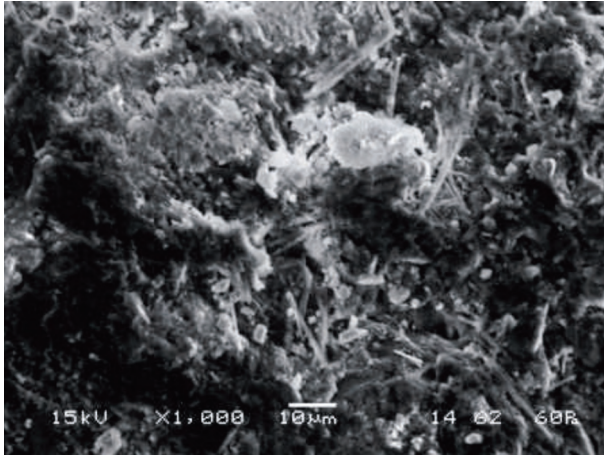
(a) Needle-like thaumasite crystals in the deteriorated mortar.

**Figure 12.** SEM photos of the deteriorated mortar (LS30) after exposure to 5% magnesium sulfate solutions at 5 °C for 360 days.

*SEM examination* The damaged mortar of LS30 exposed to  $\text{MgSO}_4$  solutions at 5 °C was selected as an example to observe the microstructure of deterioration products, and the SEM images are shown in Figure 12. No portlandite ( $\text{Ca}(\text{OH})_2$ ) crystal existed in the sulfate-attacked mortar, and many club-shaped or needle-like crystals were embedded irregularly in the pulpy material with a very open microstructure. Figure 12a shows a large number of needle-like thaumasite crystals, smaller than  $0.5 \mu\text{m}$  in diameter and  $3\text{-}4 \mu\text{m}$  in length, and the existence of different morphologies of the C-S-H gel in the specimen covering the mortar surface before sulfation. In the pores or surface cracks, there were many club-shaped gypsum crystals, which had much larger sizes than the thaumasite, as shown in Figure 12b. The formation of both thaumasite and gypsum led to the

cracking, spalling, and decomposition of the limestone filler cement mortar exposed to a sulfate environment. The combination of XRD and SEM led to the positive identification of the deterioration products' formation.

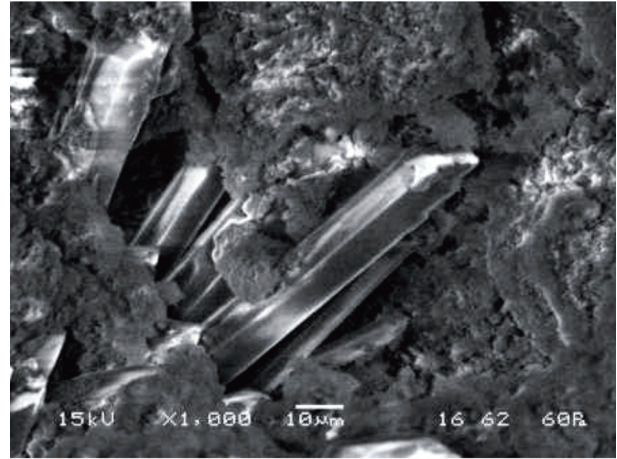
(b) Club-shaped gypsum crystals in the deteriorated mortar.
