## The process of creeping discharge-caused damage on oil/pressboard insulation

**Abstract:** This paper presents experimental research on creeping discharge by using cylinder-plate electrode configurations under AC voltages. The process of creeping discharge-caused damage on the oil/pressboard insulation was studied. First, the electric field distribution was achieved by Multiphysics software simulation. Afterwards, the phenomena that occurred in the entire damage process, such as “white smoke”, “white mark”, and “black mark”, were recorded and analyzed. Furthermore, the micromorphology of the oil-impregnated pressboard was observed via scanning electron microscope (SEM). Finally, the inner mechanism of the damage to the oil/pressboard insulation was explored according to the phenomena and the SEM morphologies. Results showed that during damage processes, the high electrical field strength (nearly 25.853 MV/m) at the weak-link point between the cylinder electrode and the pressboard directly caused the incipient discharge. The cavity, moisture, impurity, solid particle, and formation of a gaseous channel all contributed to the development of the damage. The “white smoke” consisted

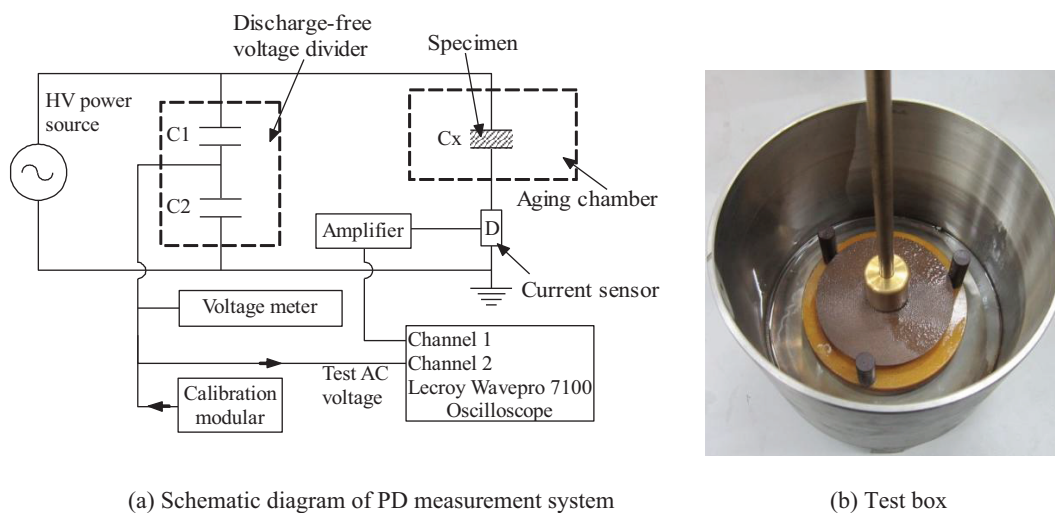
**Figure 1.** The schematic diagram of PD measurement system (a) and experimental test box (b).

The oil/pressboard insulation consists of insulation oil and insulation pressboard. In this paper, Kraft pressboards (thickness: 2 mm; diameter: 80 mm), which was provided by a local company, was used in the damage experiments. The 25# transformer mineral oil was chosen as the insulation oil. The discharge measurement system and the test box are shown in Figures 1a and 1b. Before discharge experiments, the oil/pressboard insulation must be preprocessed to simulate the real transformer. The pretreatment of the samples was divided into three steps, as discussed in the following paragraphs.

A cylinder-plate model was used to make the simulation closer to the real situation. The top view of the test box is shown in Figure 1b. The pressboard was surrounded by three epoxy columns, which were used to fix the pressboard. The entire model was placed in a steel container filled with oil. Before the experiment, various explorative damage experiments were conducted. The subsequent test method was as follows: the applied voltage was increased gradually and finally kept at a constant voltage (32 kV) until the failure of oil/pressboard insulation. The entire damage process and the phenomena were recorded by a camera.

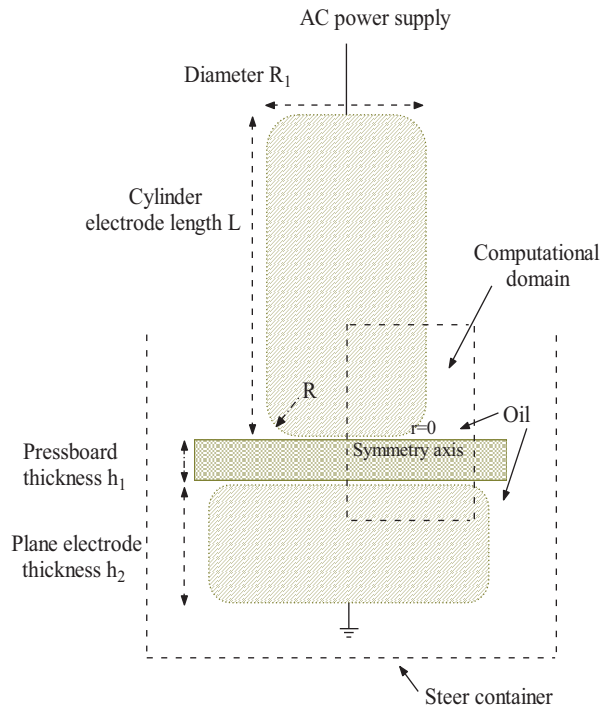
**Figure 2.** Cylinder-plate electrode system model.

A schematic diagram of the cylinder-plate electrode system model is shown in Figure 2, which is simplified into a two-dimensional representation using a rotational symmetry. The model was solved using COMSOL Multiphysics based on the finite element method. The model consisted of a cylinder electrode with diameter R (25 mm) and height L (50 mm), a plate electrode with diameter of 60 mm and thickness  $h_2$  (10 mm), and a pressboard with diameter of 80 mm and thickness  $h_1$  (2 mm). An oil slick with thickness of 0.1 mm was established at the top and bottom layers of the pressboard because the pressboard was a kind of oil-impregnated pressboard and its surface was filled with oil.

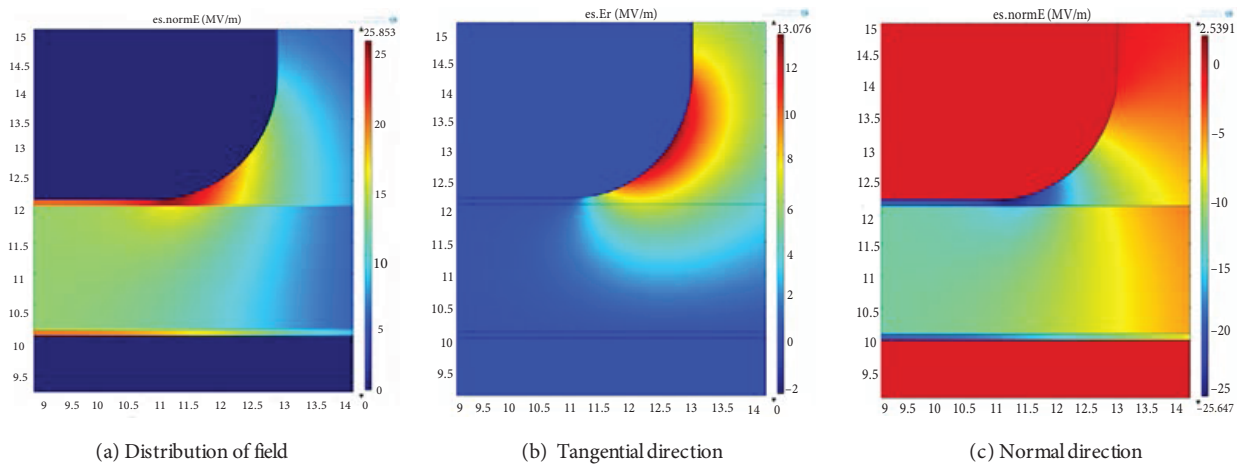
**Figure 4.** The simulation results of cylinder–plate electrode model: (a) distribution of field, (b) tangential direction, (c) normal direction.

Figure 4 demonstrates the simulation results, including the distribution of the entire electric field, the tangential electric field, and the normal electric field. In Figures 4a and 4b, the red color represents a high electric field and the darker color indicates a higher field. The blue color represents a low electric field and the darker color denotes a lower field. The normal direction is defined as the direction perpendicular to the plane and the points from the bottom to the top in general. Hence, the meaning of the colors with regard to the electric field in Figure 4c is opposite to the meaning in the other two figures.

Figure 4a shows the overall distribution of the electric field. It is obvious that the value of the electric field inside the oil is higher than that inside the pressboard, particularly in the areas between the cylinder

electrode and the pressboard. This result is attributed to the electric field strength of each layer dielectric, which is inversely proportional to its permittivity. In addition, the peak value of the electric field reaches nearly 25 MV/m. The distribution of the tangential electric field is shown in Figure 4b. The maximum value reaches 13.08 MV/m. A closer distance to the cylinder indicates a higher value of the tangential electric field. The distribution of the normal electric field is shown in Figure 4c. The absolute value of this distribution reaches 25.65 MV/m.

However, the electrical field in the area with a diameter of greater than 13 mm, as shown in Figure 4a, reaches only 8 MV/m or less. This value is significantly small, and thus the discharge does not appear. Interestingly, Figure 5b–5d show that a “white mark” appears on the pressboard surface and vast swarms of bubbles are observed in the bulk oil. It was reported that the emergence of a “white mark” is caused by the bubbles that stem from oil ionization resulting from discharge [23], thus indicating that the discharge still exists. Thus, bubbles have an important role in distorting the electrical field. A continuous discharge is supported by the distorted electrical field caused by the bubbles. Hence, an electric field distribution simulation of the cylinder-plate model with the presence of bubbles was conducted, as shown in Figure 7. The result indicates that the initial distribution of the balanced electric field is disturbed with the introduction of gas because of its lower permittivity compared with that of oil and pressboard. The maximum value of the electric field reached nearly 25 MV/m inside the bubbles, thus facilitating the development of discharge and the damage to the oil/pressboard insulation.

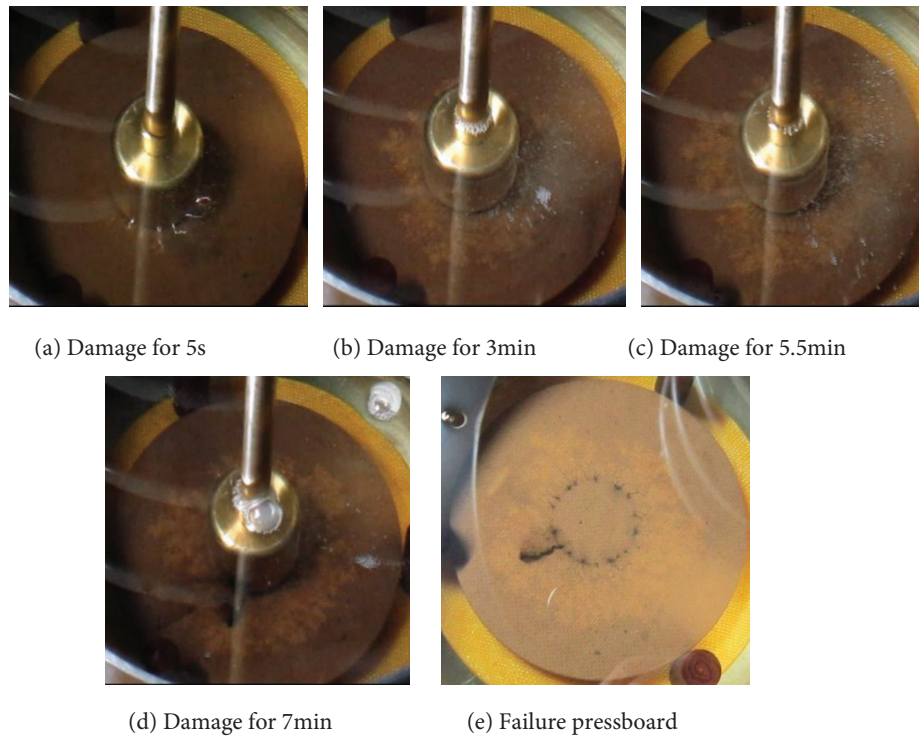
**Figure 5.** The electrical damage progress of oil-impregnated pressboard: (a) damage for 5 s, (b) damage for 3 min, (c) damage for 5.5 min, (d) damage for 7 min, (e) failure of the pressboard.

The changes in the macrophenomena were observed via a video camera during the entire damage process. These changes could be classified into four typical damage stages, as shown in Figures 5a–5d. The surface morphology of the pressboard after breakdown is shown in Figure 5e.

During the beginning of the damage process, a discharge spark occurred on the surface of the oil-impregnated insulation pressboard when it was subjected to the sustained damage for 5 s, as shown in Figure 5a. The discharge spark started and developed in clockwise and counterclockwise directions, respectively, around the cylinder electrode. Interestingly, a “white mark” and “white smoke” appeared on the surface of the pressboard and in the bulk oil with air bubbles adsorbed by the cylinder electrode when the damage to the oil–pressboard insulation lasted for 3 min, as shown in Figure 5b. Surprisingly, it is obvious that the “white mark” area expanded compared with the second damage stage, as shown in Figure 5c. However, the expansion speed of the area eventually slowed down or the area did not expand anymore, as shown in Figure 5d. A large quantity of air bubbles and a “black mark” appeared with the failure of the oil/pressboard insulation caused by discharge. Figure 5e clearly shows that the “white mark” and “black mark” remained on the surface of pressboard and could not be recovered. The damage status of the pressboard changed from local damage to complete failure.

The surface of the oil-impregnated pressboard in the oil/pressboard insulation system is regarded as the weak link; the dielectric strength of the oil gap generally decreases with the introduction of an insulation pressboard [22]. The oil gap between the cylinder electrode and the pressboard typically becomes the overstressed and high-field strength point, wherein the initial discharge spark occurs. As we all know, discharge occurs when the electrical potential gradient reaches 16 MV/m. The simulation results presented in this paper shown in Figure 4a indicate that the electrical field strength in the oil gap reaches 25.853 MV/m, which is greater than 16 MV/m. Accordingly, a discharge spark with a huge amount of energy occurs, as shown in Figure 5a. The simulation analysis directly affects the experiments.

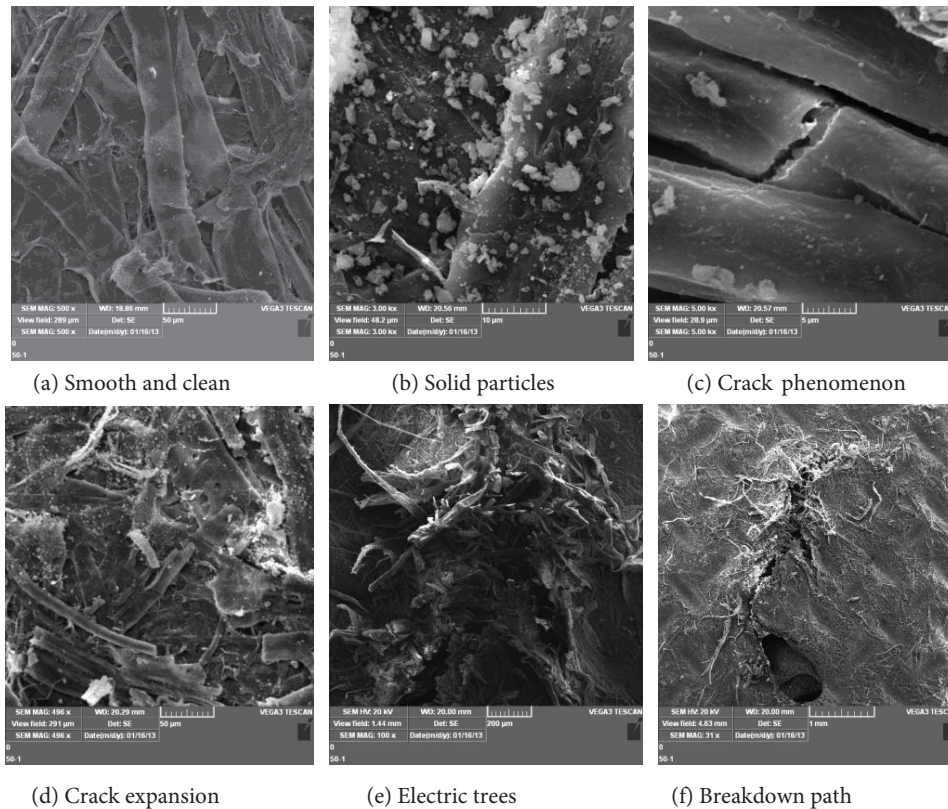
**Figure 6.** Surface damage SEM images of oil-impregnated pressboard: (a) smooth and clean, (b) solid particles, (c) crack phenomenon, (d) crack expansion, (e) electric trees, (f) breakdown path.

The surface morphology of the oil-impregnated insulation pressboard was obtained via SEM during the entire damage process, as shown in Figures 6a–6f. The surface damage can be classified into several stages as well.

The surface of the fiber seemed smooth and clean before the damage, as shown in Figure 6a. However, white particles appeared on the surface of the oil-impregnated pressboard and covered each fiber during the

start of the damage process. The crack phenomenon was then observed on the cellulose fiber, thus indicating that irreparable damage had formed, as shown in Figure 6c. As the damage continued, a large number of cellulose fibers broke down and “pitting” was formed, which became increasingly large, as shown in Figure 6d. Consequently, the “pitting” evolved into the start point or the source of the electric tree and randomly propagated to many directions, as shown in Figure 6e. A final breakdown channel with a “black hole” connecting to the channel end was formed, as shown in Figure 6f.

The rough surface of the pressboard increases the probability of discharge because the raised points, such as solid particles, play an important role in distorting the electric field. The distorted electric field destroys the pressboard and breaks down, as shown in Figure 6c. The pitting formed by the crack of cellulose fibers and the accumulation of solid particles increases surface roughness, thus leading to a serious distorted electric field. Accordingly, the pitting evolves into the start point of the electric tree, which damages the pressboard further. The damage procedure according to the microperspective level can be summarized as shown in Figure 9.

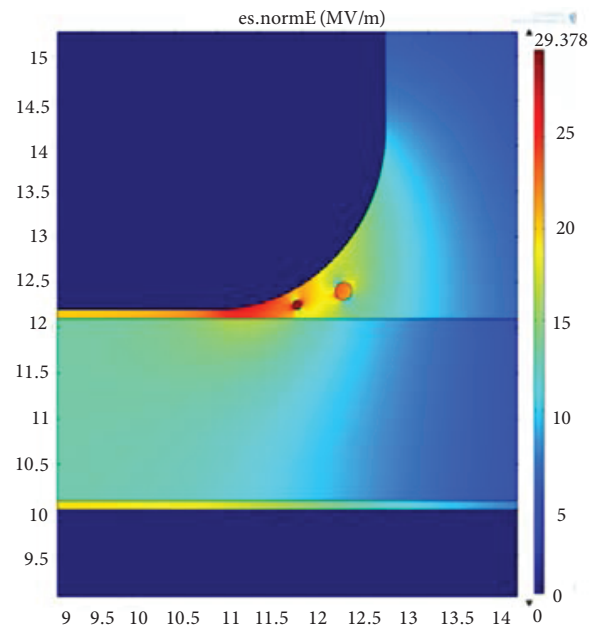
**Figure 7.** Field distribution with bubbles.

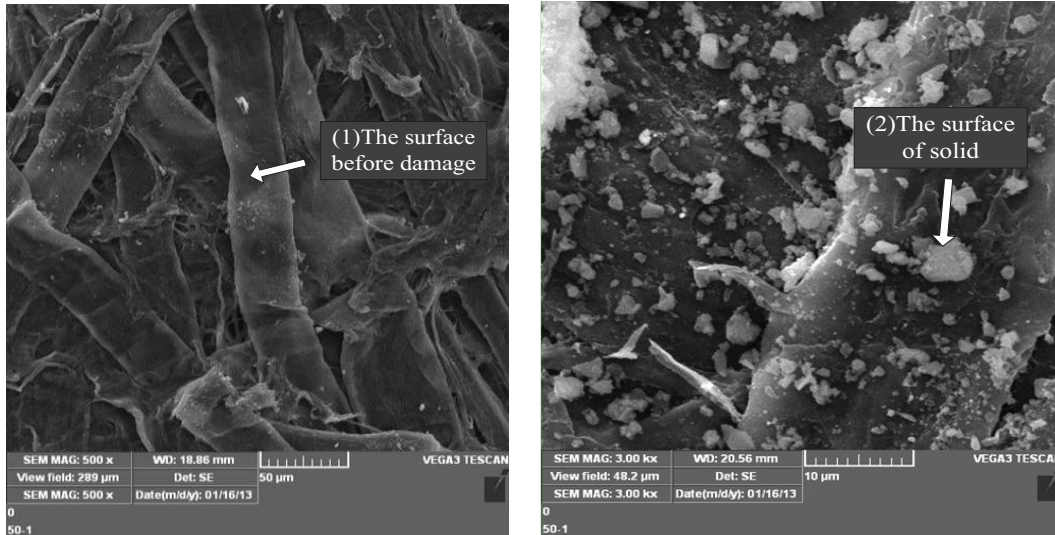
**Figure 8.** Two points were selected for elemental analysis.

elemental analysis for the insulation pressboard was conducted by energy dispersive X-ray (EDX) spectrometry. For comparison, two points were selected for the elemental analysis, as shown in Figure 8.

The result of the elemental analysis is shown in Table 3, which reveals an increasing tendency of C content, which indicates that the pressboard suffers from carbonization effects and irreversible damage has started. The main component of the solid particle was carboxylic acid, which was generated from the oxidation reactions of decomposition products under the effect of discharge [25]. Thus, it is suggested that the emergence of solid particles or a “black mark” is a sign of the start of the irreversible damage to the pressboard caused by changes in physical and chemical properties of the pressboard.

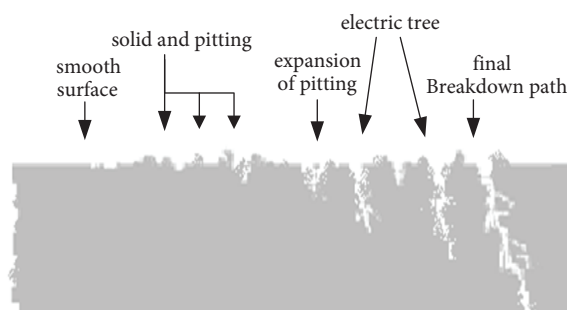
**Figure 9.** The damage process of the pressboard in the microperspective.
