Impacts of the 2020 Samos earthquake on the modeling of ancient seismic events

Stathis C. STIROS*

Department of Civil Engineering, Patras University, Patras, Greece

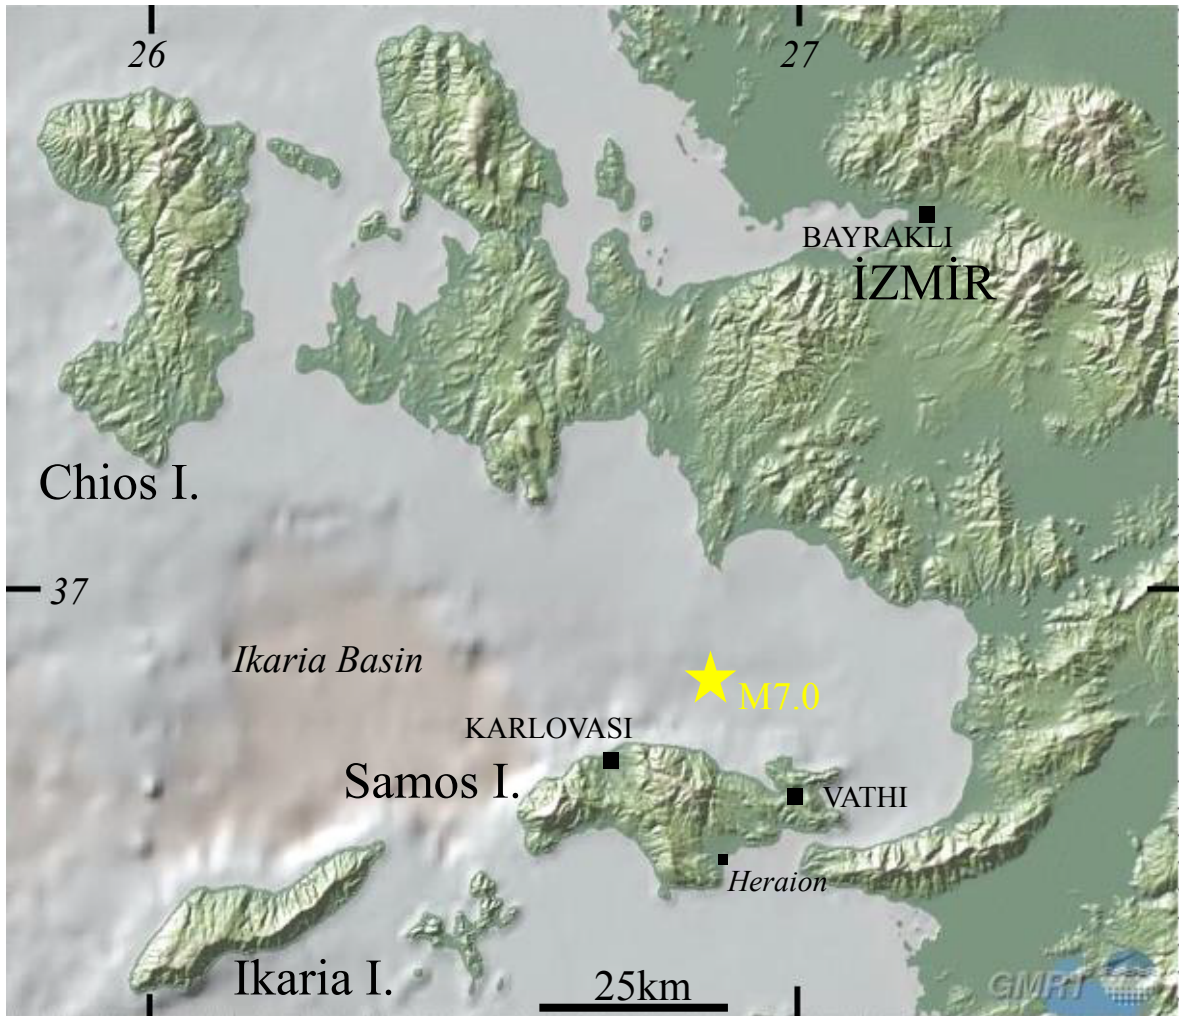
Figure 1. Major damage of the Samos 2020 earthquake was characterized by a bi-modal pattern and was limited to two main areas: in the nearfield, in the northern part of the Samos Island (especially in the two main towns, Vathi and Karlovasi), and in the far-field, in the Bayraklı District of the İzmir metropolitan area. A star indicates the location of the epicenter. The causative normal fault runs along the north coast of Samos Island, but its precise geometry is a matter of debate (see references in the Introduction Section). Figure is based on GMRT background.

In fact, the 2020 earthquake produced important horizontal acceleration in Samos, with a maximum recorded PGA 0.23 at Vathi (for location see Figure 1) and damaged about 8% of the ~24,000 buildings in the island (ITSAK, 2020; Cetin et al., 2020). Still, this statistic should be read in a different way. Most of the damaged buildings were made of masonry and lath-and-plaster, and in their majority were non-inhabited, in bad condition, and hence, they were highly vulnerable to shaking even by moderate seismic shocks. Consequently, the 2020 damage level in Samos was much lower than what is typically expected in the nearfield of a M7.0 earthquake.

This result may be used to explain the offsets of the column of the Heraion Temple (Figure 6) at Samos (for location see Figure 1). Stiros et al. (2000) and Stiros (2020) have assigned the offset drums to earthquakes, which

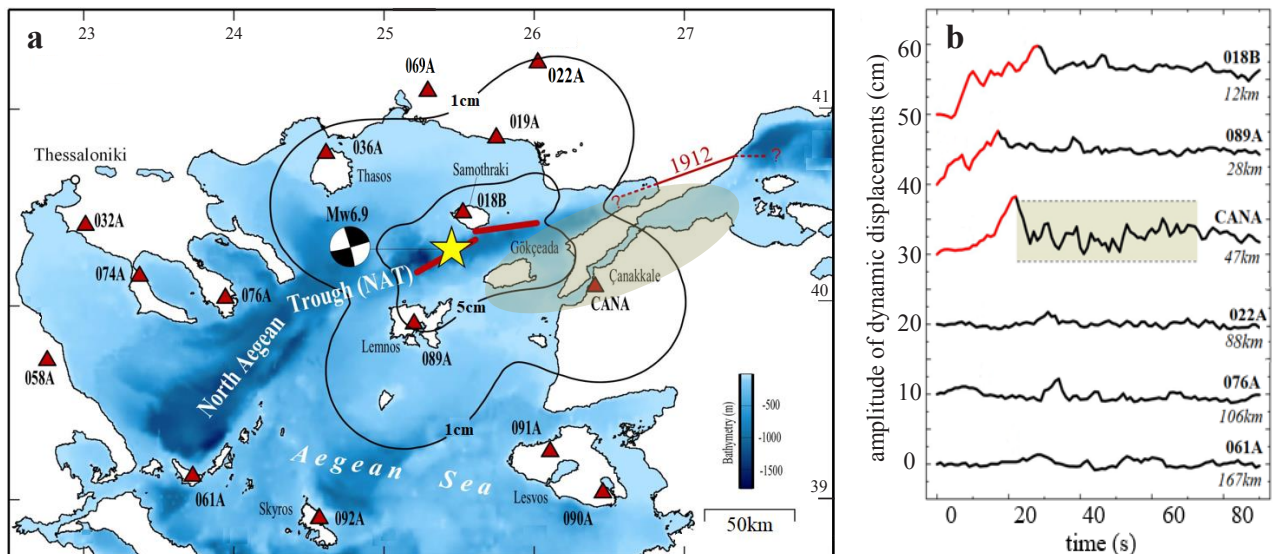
Figure 2. Dynamic displacements of the 2014 Samothraki-Gökçeada earthquake. **a:** Location map showing GNSS stations (red triangles), epicenter (star), faults (solid red lines), and contours of static displacements (“fling steps”) of 1 and 5 cm (black lines). Shading indicates areas of increased intensities, mostly in the far-field. **b:** Time series of the amplitude of GNSS-derived horizontal dynamic displacements for selected stations; epicentral distance is marked below station code. Station CANA at Çanakkale shows dynamic displacements with maximum amplitude essentially similar to that in stations in the nearfield and with nearly double duration (shaded); this is evidence of amplification of seismic movement. Records of each station are displaced by 10 cm for clarity.

province of Turkey; location indicated by arrow and C in Figure 2a). This is indeed the only case of a major Roman temple for which there is a clear historical report that it was partly destroyed by a 2nd century AD earthquake (*Dio Cassius, Epit 70.4*), while its remains were partially obliterated in later periods and were found only recently (see Stiros 2020). The history of earthquakes of this period is unclear (Guidoboni et al., 1994), and hence different scenarios can be proposed. Reactivation of a strand of the North Anatolian Fault crossing the Sea of Marmara about 40km north of Cyzicus, or reactivation of a smaller fault passing close to Cyzicus (Figure 1 in Meghraoui

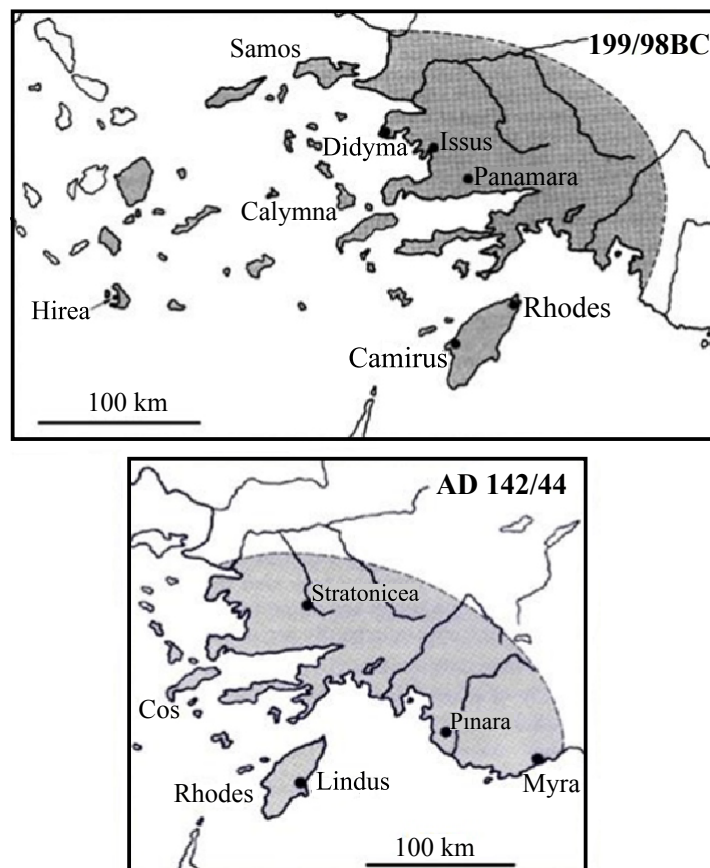
Figure 3. Meizoseismal areas (or affected areas) of the 199/98BC and AD142/144 earthquakes in the SE part of the Aegean. After Guidoboni et al. (1994) with additions. Note similarities in the order of magnitude of the meizoseismal (or affected) zones of the two events, which seem to be too large for modern experience.

damage in a map, and then produce a diagram of the affected areas, or of the meizoseismal areas of the earthquakes (Figure 3). This approach, however, is qualitative, and does not provide estimates of main parameters of an earthquake such as epicenter or magnitude. If, however, observations of different levels of damage are available for different sites, they may be converted into intensities, and hence, isoseismal curves can be produced. Intensities are usually in the form of ellipses (Figure 4), and the center of the area of maximum intensity corresponds to the epicenter of the earthquake. It has been found that the epicenter derived from intensities (macroseismic epicenter) is within 30 km from the epicenter derived from analysis of seismograms (Ambraseys and Melville, 1982). Exploiting the geometry of the contours of intensities, certain quantitative parameters of earthquakes can be computed (cf. Ambraseys and Jackson, 1998), and parametric catalogues of earthquake can be compiled, though with the reservation that some of their data may be questionable (Rovida et al., 2020).

These simple arguments can be used to question whether for example, large meizoseismal areas such as those of Figure 3 may indeed reflect unusually large events, exaggeration by ancient sources, wrong interpretations of the ancient sources, possible multiple events regarded as one, or even Samos-type events.

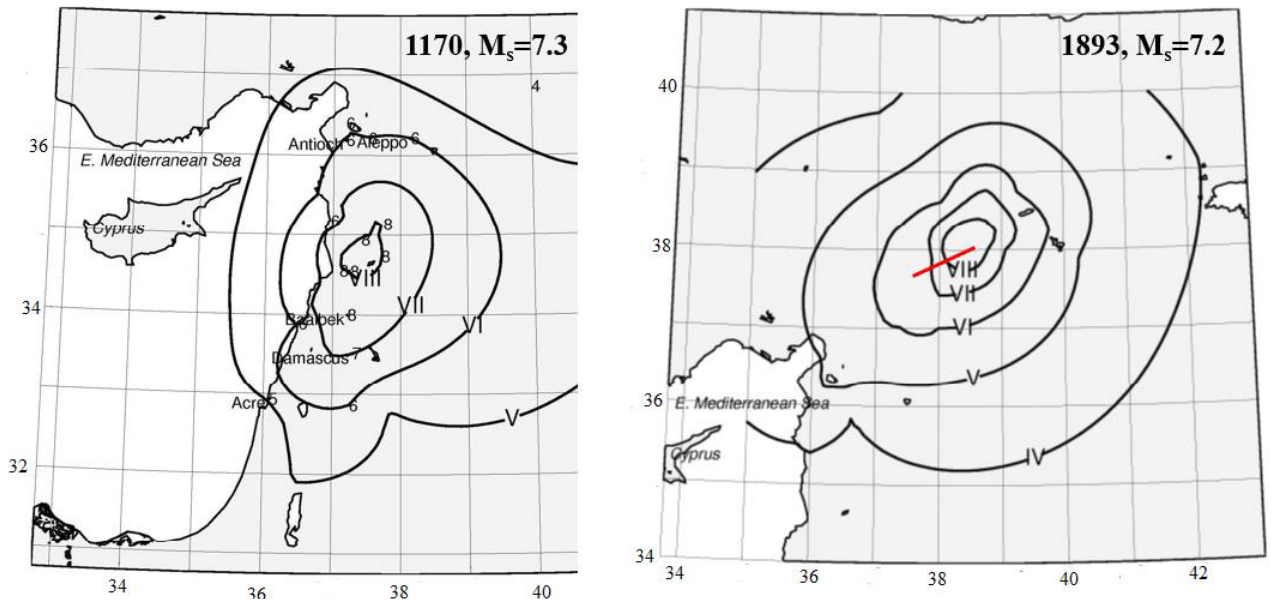
Figure 4. Isoseismal contours of the 1170, $M_s=7.3$ and 1893, $M_s=7.2$ earthquakes. After Ambraseys (2009) with additions. Longitude degrees roughly correspond to 100km. A red line in the graph of the 1893 epicenter indicates the reactivated fault according to Duman and Emre (2013) and Taymaz et al. (2021), slightly offset relative to the area of maximum intensities.

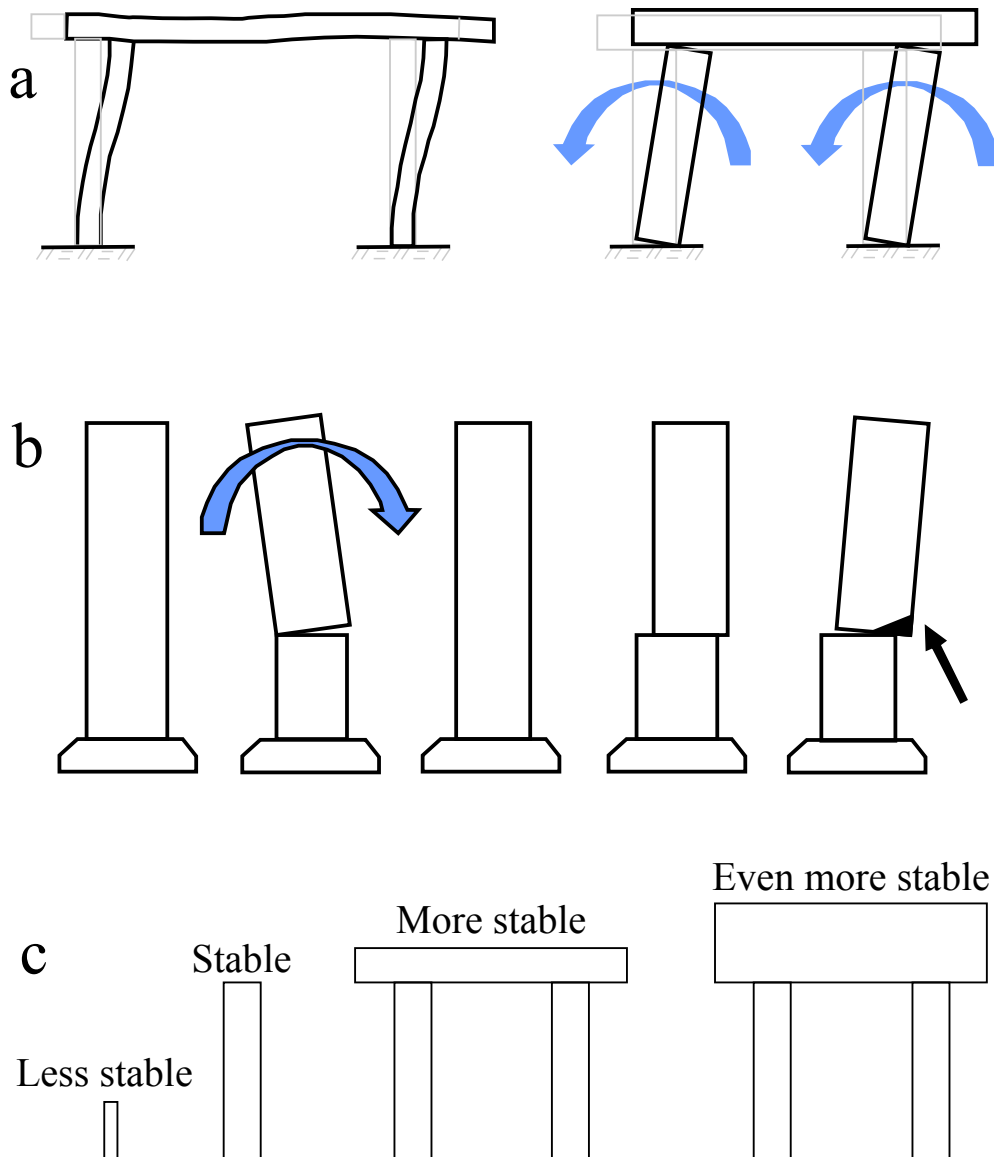
Figure 5. Pattern of instantaneous deformation of ancient monumental ancient Greek and Roman temples during earthquakes. a: Differences in the response of a typical rigid structure (made with concrete) from that of a multiblock temple (mechanism). b: Response to an earthquake of a multidrum column by rocking. Failure (or missing wedge, marked black) modifies the pattern of oscillation and may lead to failure. Blue arrows indicate a torque opposing to the seismic tilting and tending to stabilize the column. c: An apparent paradox in the seismic performance of ancient Greek and Roman columns and temples: stability increases with the column height and the load of horizontal beams (architraves). (a), (c) after Makris (2014) and Makris and Vassiliou (2014); (b) modified after Sinopoli (1989).

Recently, it was found that in addition to these effects, seismic tilting of a part of a column generates a torque counteracting tilting, a natural oscillation damping mechanism. This torque (schematically shown as a curved arrow in Figures 5a, b) is equal to the weight of the tilting part times distance of the center of mass from the edge of rotation of the upper part of the column, and is higher in tall and slender columns, and in rotating parts with a heavy load on top (a beam, architrave; Figure 5c; Makris, 2014; Makris and Vassiliou, 2014). Furthermore, modeling and experiments, mostly of isolated columns, tend to support this idea and tend to indicate that the seismic collapse of columns is possible only under extreme seismic accelerations. Hence, it has been concluded that survival of standing ancient columns could be regarded as evidence of absence of very strong seismic accelerations, mainly characterized by long-period pulses (cf. Psycharis 2007; for a review see Stiros 2020).

However, historical data provide evidence of failure of ancient classical temples, and this may be due to weaknesses in structures; for example, mechanical failure at the rotating edge of a drum, marked by a black arrow in the middle row of Figure 6) may lead to removal of a wedge (black part) and to lead to seismic collapse of a column, even of part of an ancient temple. These are realistic scenarios supported by historical evidence; for example, one of the columns of Roman, Olympieion temple in Athens collapsed during an extraordinary storm in 1853 (Stiros, 2020).

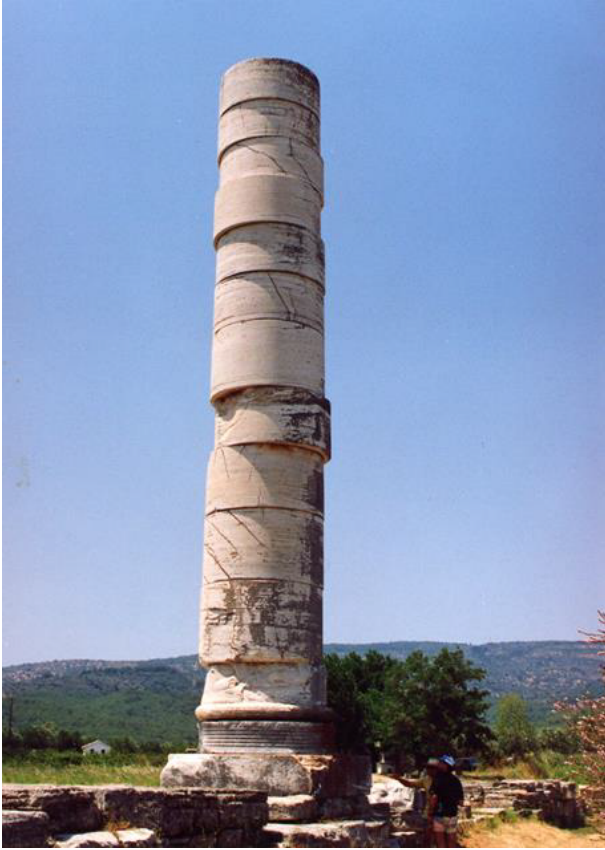
Figure 6. Offsets between drums are clear in the only surviving column of the Heraion Temple in Samos (for location see Figure 1) and originate from oscillations (rocking) during strong earthquakes, as explained in Figure 5.

produced significant coastal uplift at the western part of the island. Evidence presented here indicates that this is not the only possibility, and other strong earthquakes, of the order of magnitude M7, at larger epicentral distances, for example with epicenters in the Anatolian mainland, may have been responsible for the deformation of the Heraion column. In fact, this temple is built on a layer of weak soil
